# Massachusetts Cultural Resource Information System

AREA	FORM NO.
	13

Town SWANSEA

Address 160 Wood Street

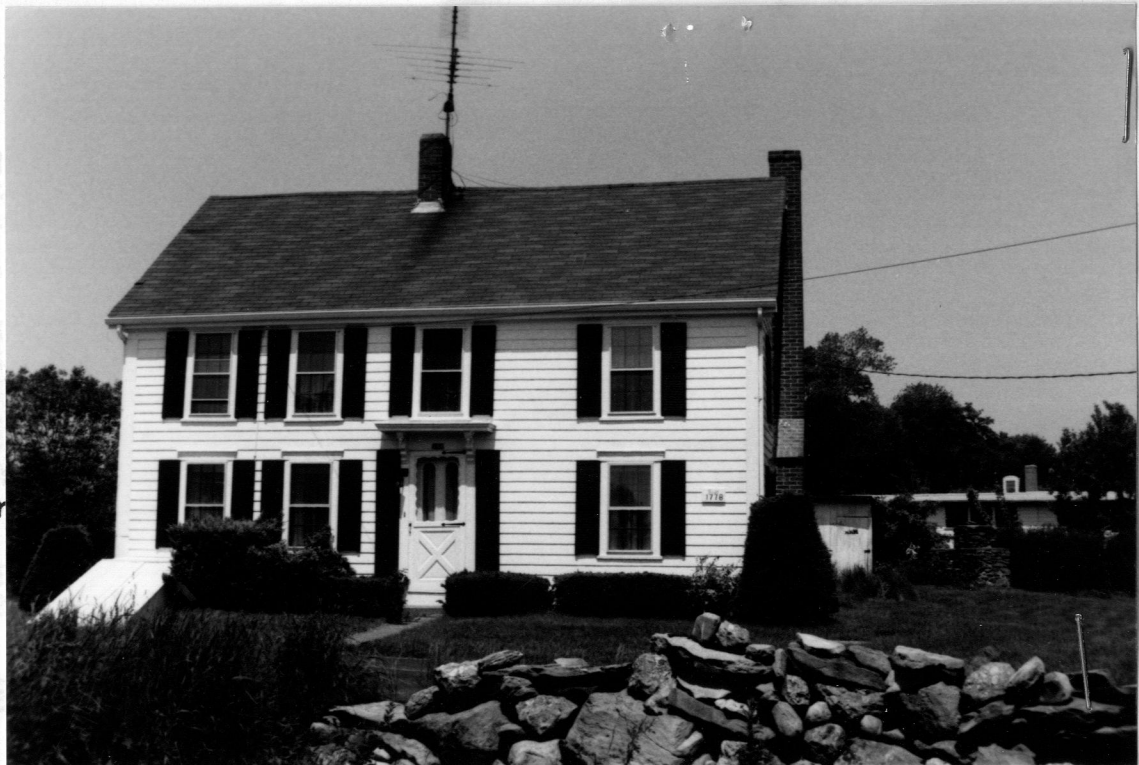
One of the few 3/4 houses with the addition of the fourth bay at a later date, in Swansea. This four-bay, 2½-story, offset center chimney is an intact example of how the 3/4 houses were added to. The rear of the west part of the house has an attached 1-story summer kitchen with a chimney. The east side is the added 2-story, 1-bay with an exterior end chimney(recent). The windows are all 6 over 6 with extended lintels. The front door and bracketed hood was added late 19th century.

Intact example of old farmstead, located with an askewed southern exposure. This location alone tells that this home was built for location and not because of land parceled that way. Located with original orchards on its property. This property shows character of rural farm life in the 1800's.
