# Massachusetts Cultural Resource Information System

AREA e FORM NO. 105

Town SWANSEA - HORTONVILLE

Address 211 Hornbine Road

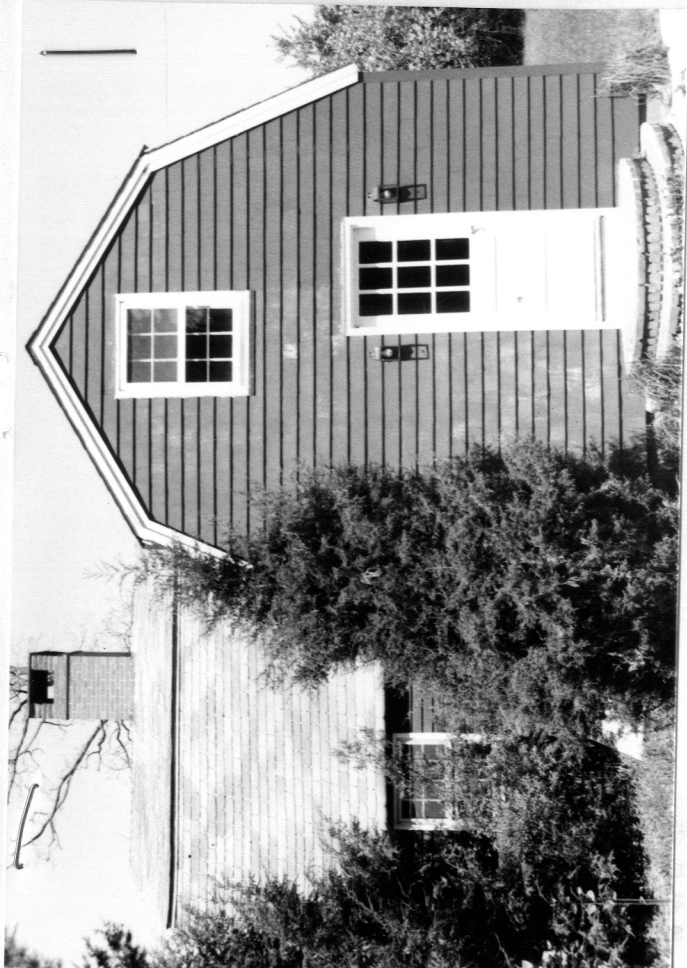
Style Colonial Gambrel

Exterior Wall Fabric Shingle

Rear ell (kitchen) added 1970's

Condition Fair - vacant at present

This unusual 1½-story, 3-bay gambrel roof structure is basically intact example of a gambrel, of which there are only a few in Swansea. Its basic massing is low and wide with no architectural detail and the windows on the side facades are altered and asymmetrical. The foundation is rubble stone and there is a central, altered, chimney.
