# Massachusetts Cultural Resource Information System

<b>Inventory No:</b>	SWN.23
<b>Historic Name:</b>	Gardner - Williams House
<b>Common Name:</b>	
<b>Address:</b>	393 Maple Ave
<b>City/Town:</b>	Swansea
<b>Village/Neighborhood:</b>	
<b>Local No:</b>	
<b>Year Constructed:</b>	C 1790
<b>Architectural Style(s):</b>	Colonial;
<b>Use(s):</b>	Agricultural; Single Family Dwelling House;
<b>Significance:</b>	Agriculture; Architecture;
<b>Area(s):</b>	
<b>Designation(s):</b>	
<b>Building Materials:</b>	Roof: Asphalt Shingle; Wall: Wood Clapboard;
<b>Demolished</b>	No

AREA	FORM NO.
	23

Address 393 Maple Street

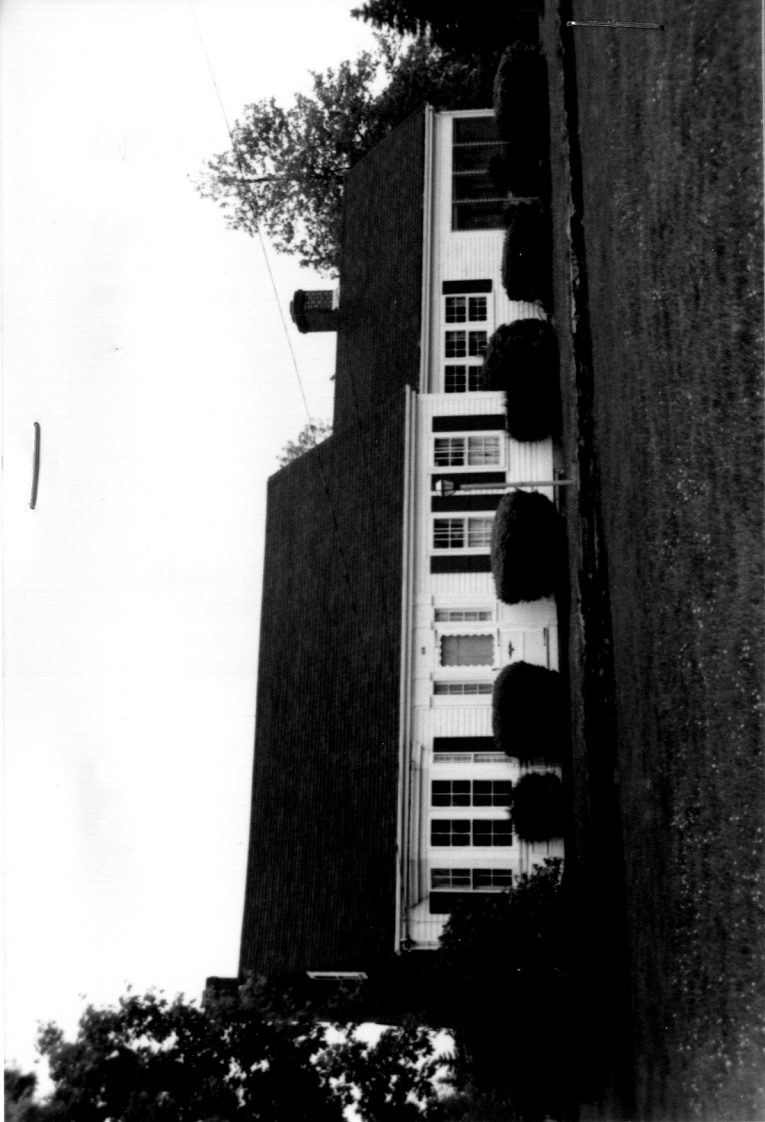
Style Colonial Cape

Exterior Wall Fabric Clapboard

addition of west wing & porch 1950's

Condition Excellent - well Maintained

The ubiquitous Cape Colonial in good condition with sensitive additions and alterations. Basic characteristics are the 5-bay, 1½-story and interior end chimney. Details feature a door surround with double pillasters and inset side lights and a wide entablature with continuation of pillasters. A bow window on the front east, added but fits well, and has three windows with 4 over 4 lights, the other windows are 6 over 6. The windows are not close to cornice line.
